PAVER SURFACE INFILTRATION LABORATORY TESTING REPORT

Report Number: 82191489.0002
Service Date: 12/06/19
Report Date: 12/09/19

Western Interlock Paver Infiltration Testing
700 Ne 55th Ave
Portland, OR 97213

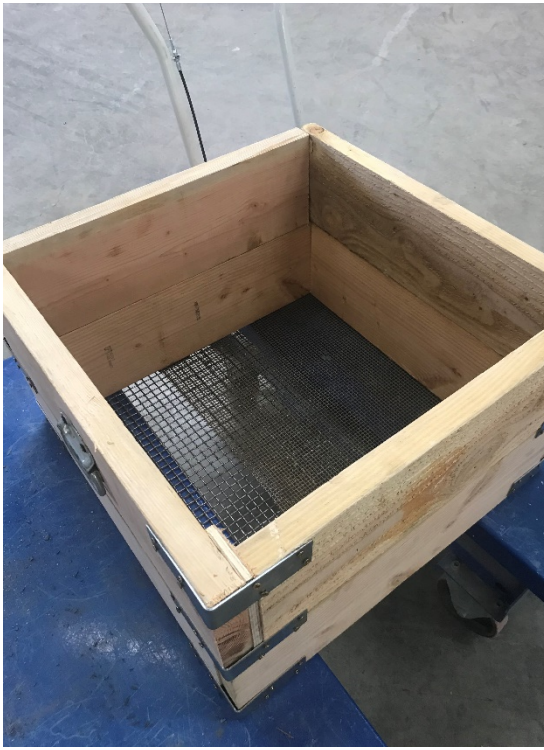
Photo #1 Empty Frame

Test Apparatus and Preparation: The tests were performed on a paver surface installed within a wood frame. The frame’s interior dimensions were a length of 22½”, a width of 22½”, and a height of 14¾”. A grid of woven steel mesh with openings approximately 4.75 mm square was securely attached to the base of the frame, allowing material to be retained inside the frame while allowing water to pass out. On top of the steel mesh, a 6” layer of open-graded 2” – 1” ballast rock from Knife River, Coffin Butte was placed; the layer was assembled by hand to ensure that the rocks were locked against each other; this was tested by applying a 20,000 lb force to the full surface of the layer utilizing a compression machine, with no visible deflection. The next layer was a 4” depth of open-graded ¾” - ½” drain rock from Reed. It was similarly hand-installed and checked against deflection. Atop this, a 1½” layer of ¼” - #10 levelling material from Reed was placed and smoothed to a level surface without compaction. Finally, the selected pattern was put in place, with pavers sawcut as necessary to ensure a

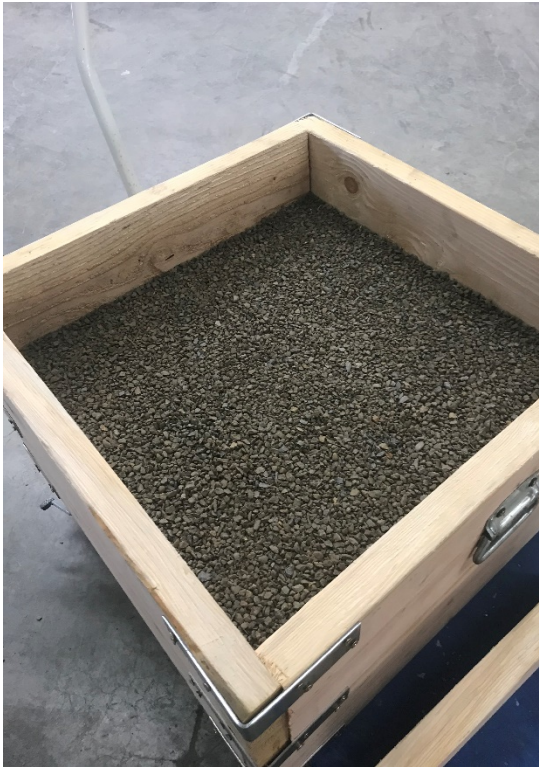
Photo #3 With Levelling Course

close fit with the frame's edges (less than 1/4"). Levelling course material was then swept into the gaps between the pavers and between the pavers and the frame, and consolidated with a slender rod until the material was firm and unyielding, with the level falling slightly beneath the surface of the pavers. Finally, a piece of timber was carefully struck against the surface of the pavers to ensure the surface was flat.

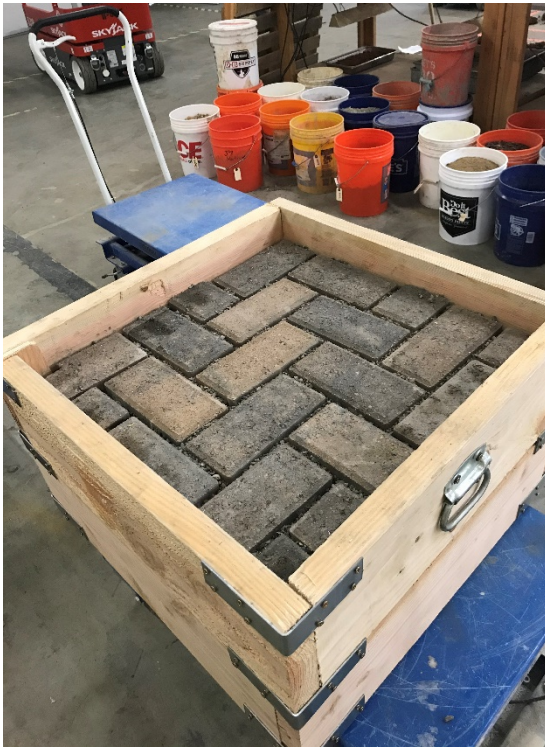
Photo #4 Herringbone as Installed

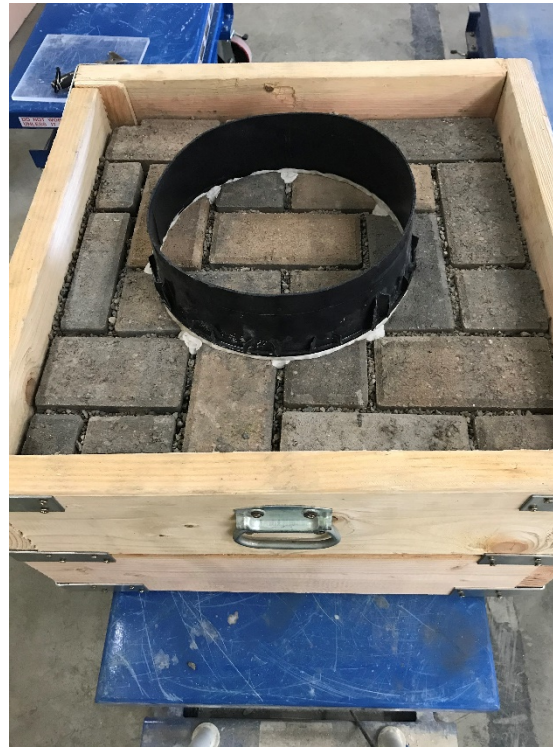
Photo #5 Herringbone as Prepped (Pre-Test)

Test Process: As per ASTM C1781, an impermeable ring was sealed to the paver surface with plumber's putty. The interior diameter of the ring was 11.58", and it was composed of rigid plastic. The surface was then pre-wetted with 8.0 lbs of municipal tap water, with the infiltration time noted to determine the mass of water to be used in the actual testing. In all cases, the infiltration time of the pre-wetting mass of water was less than 30 seconds, and so 40.0 lbs of tap water was utilized for the three infiltration sub-tests performed on each installation pattern. At least one hour was allowed to pass in between tests, to allow the pavers and aggregate to drain.
