# PAVER SURFACE INFILTRATION LABORATORY TESTING REPORT

Report Number: 82191489.0003

Western Interlock Paver Infiltration Testing  
700 Ne 55th Ave  
Portland, OR 97213

Project Number: 82191489

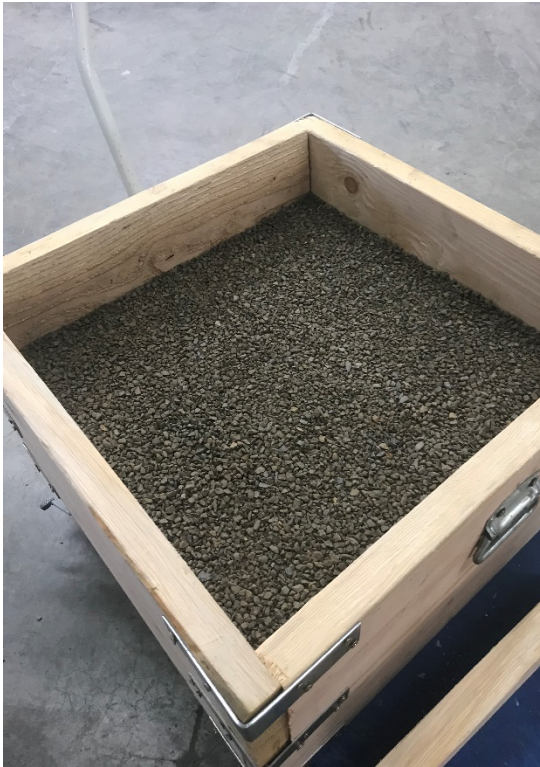
**Photo #3** With Levelling Course

close fit with the frame's edges (less than 1/4"). Levelling course material was then swept into the gaps between the pavers and between the pavers and the frame, and consolidated with a slender rod until the material was firm and unyielding, with the level falling slightly beneath the surface of the pavers. Finally, a piece of timber was carefully struck against the surface of the pavers to ensure the surface was flat.

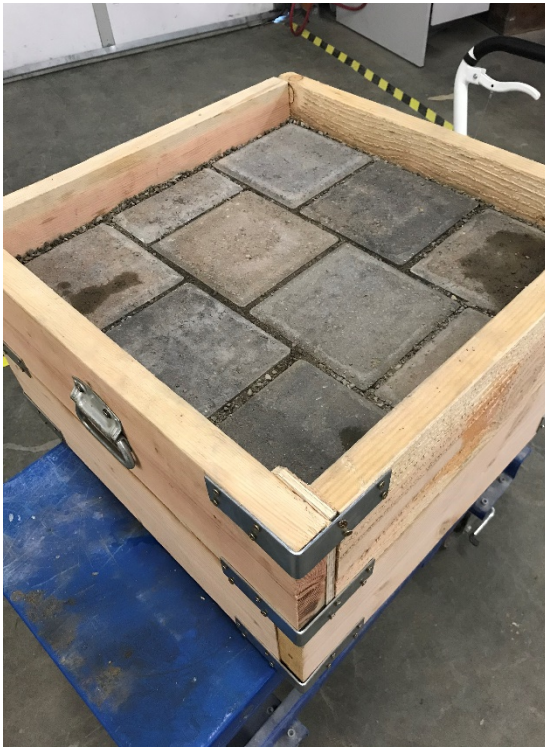
**Photo #4** Running Bond as Installed

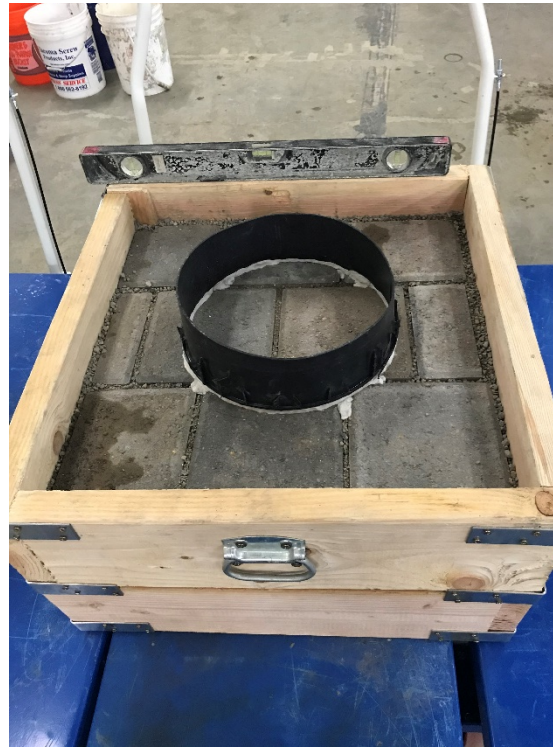
**Photo #5** Running Bond as Prepped (Pre-Test)

**Test Process:** As per ASTM C1781, an impermeable ring was sealed to the paver surface with plumber's putty. The interior diameter of the ring was 11.58", and it was composed of rigid plastic. The surface was then pre-wetted with 8.0 lbs of municipal tap water, with the infiltration time noted to determine the mass of water to be used in the actual testing. In all cases, the infiltration time of the pre-wetting mass of water was less than 30 seconds, and so 40.0 lbs of tap water was utilized for the three infiltration sub-tests performed on each installation pattern. At least one hour was allowed to pass in between tests, to allow the pavers and aggregate to drain.

<u>Elapsed Time</u>	<u>Infiltration Rate</u>
Subtest 1:	35.2 seconds	1,075 inches per hour
Subtest 2:	35.3 seconds	1,072 inches per hour
Subtest 3:	34.8 seconds	1,087 inches per hour
<b>Average:</b>	<b>35.1 seconds</b>	<b>1,078 inches per hour</b>
